# Manhole Inspection Summary

Manhole # S25Q\_\_015MH

Insp Date: **4/8/08 12:14 PM**

**Location** Address: **1227 WARD-CARROLL ST.**

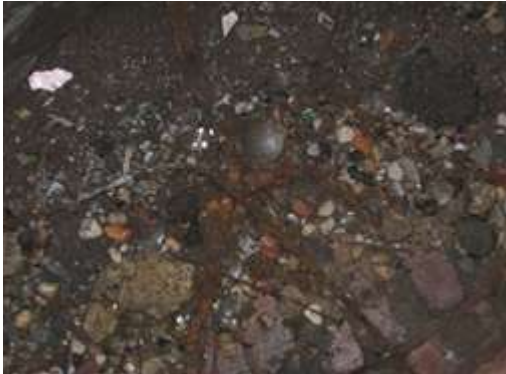
Misc 1

LIGHT DEBRIS ON THE BENCH

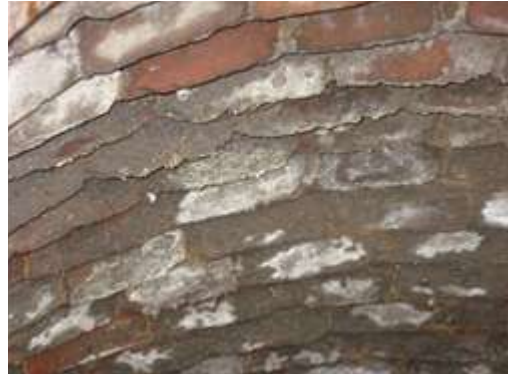
Defect 2

Infiltration: ☐ None ☐ Joint ☐ Cracks ☒ Mortar ☐ Roots ☐ Wall

Infiltration: ☐ None ☐ Joint ☐ Cracks ☐ Mortar ☐ Roots ☒ Wall

infiltration at chimney mortar and corbel & barrel walls

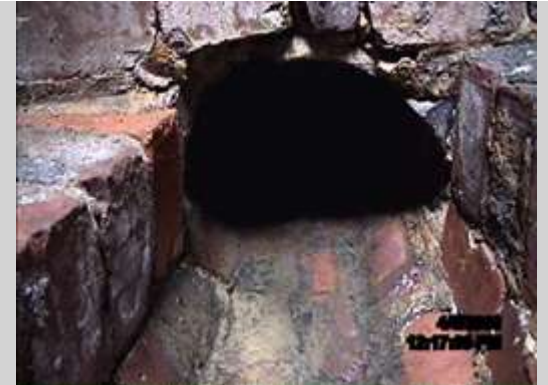
12 O'Clock Outflow

8 in. Circular Gravity Sewer  
Pipe Out @ 12 O'Clock

Pipe Height: **8.4** (in.) Rod and Bar (Angled)  
Pipe Material: **Clay** ☐ Pipe Lined  
Invert Depth: **6.33** (ft.) Flow Characteristics: **Fast**  
Deposits: ☒ None ☐ Mud ☐ Sludge ☐ Debris ☐ Grease  
Silt Depth: **0** (in.) Deposits Extent:  
Infiltration: **Evidence** Pipe Seal Cond: **Cracked**

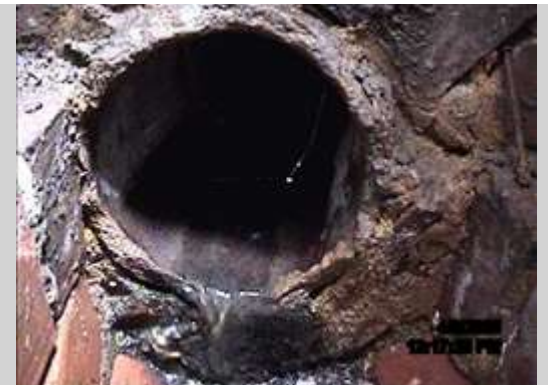
8 O'Clock Inflow

6 in. Circular Gravity Sewer  
Pipe In @ 8 O'Clock

Pipe Height: **6** (in.) Rod and Bar (Angled)  
Pipe Material: **Clay** ☐ Pipe Lined  
Invert Depth: **5.80** (ft.) Flow Characteristics: **Fast**  
Deposits: ☒ None ☐ Mud ☐ Sludge ☐ Debris ☐ Grease  
Silt Depth: **0** (in.) Deposits Extent:  
Infiltration: **Evidence** Pipe Seal Cond: **Unknown**
